Wasp Nest Infestation - Alert

AWB 02-052 Issue : 2
Date : 23 March 2016

AIRWORTHINESS BULLETIN

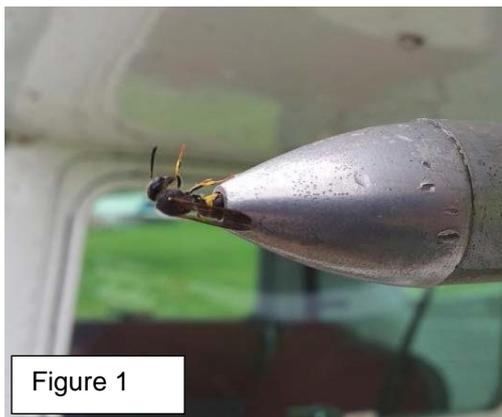
Figure 1. Mud dauber wasp emerging from an uncovered pitot tube.
(Source:backcountrypilot.org)

1. Install pitot / static and vent covers any time the aircraft is parked.
2. Consider installing approved fuel vent screens or removable drain/vent covers and engine compartment blanks, as well as installing tight fitting pitot / static vent covers.
3. In instances where the aircraft has been stored long term in the open air, remove inspection panels before flight as required to inspect unsealed wing and fuselage cavities etc.
4. Continually monitor and remove any wasp nesting sites in the general area where the aircraft is stored or maintained in accordance with appropriate insect control procedures.
5. Be aware that on-ground pre-flight air data module BITE tests and/or computer checks will usually not test pitot probes or static vents for blockages.

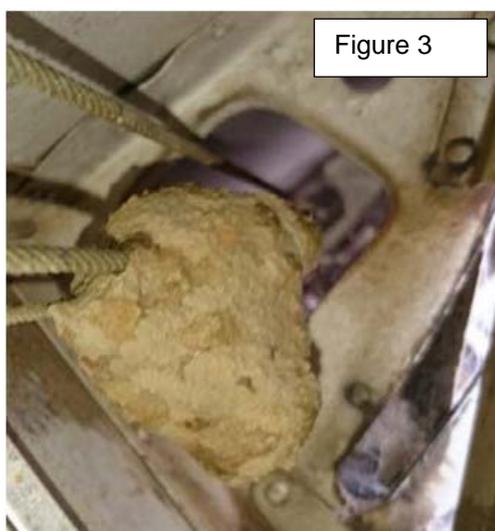
Mud dauber wasps will build a nest in any available cavity.

A recent SDR investigation found a number of wasp nests inside the wing of a Cessna 182, in the cavity formed between the rear spar and the flap fairing, (Figure 3).

There was also one large wasp nest entirely suspended on the flight control cables in the rear fuselage.

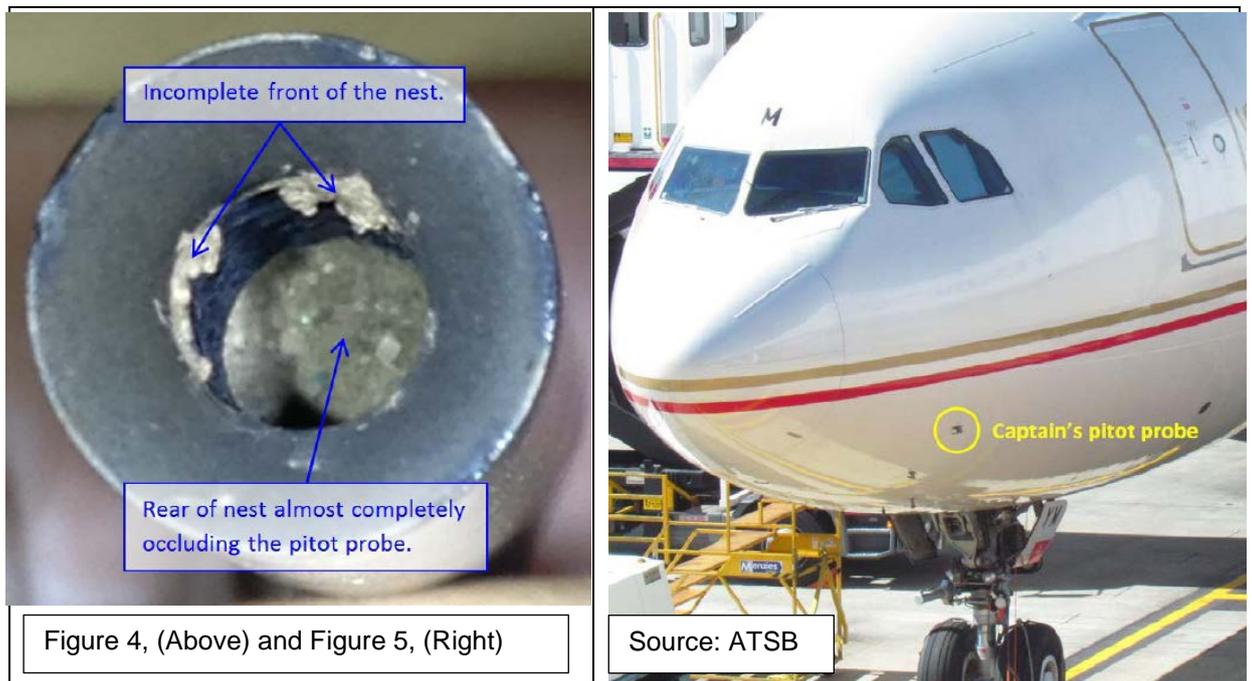
A typical example occurred in 2013 when an Airbus A330 suffered a rejected take-off in Brisbane, Australia, due to an airspeed indication failure which was only detected during the take-off roll. During the subsequent inspection it was found that the Captain's pitot probe (Figure 5) was almost totally obstructed by an insect nest, consistent with mud-dauber wasp nest residue. (Figure 4)

The residue was built up while the aircraft was on the ground over a two hour period, while the aircraft was parked at the loading gate. The pitot probe covers were not installed by maintenance staff during this time.

While the ATSB Report [AO-2013-212](#) in relation to this occurrence indicates that a mud dauber wasp nest can completely block a pitot tube inside two hours, CASA has received anecdotal evidence which indicates that the mud dauber wasp can build a significant nest capable of completely blocking a pitot tube, vent, or drain in around 20 minutes.
