ZÁVAZNÝ SERVISNÍ BULETIN / MANDATORY SERVICE BULLETIN

TÝKÁ SE / CLARIFICATIONS: Damage to the flap drive torque tube in the fuselage.

OVLIVNĚNÉ VÝROBKY / AFFECTED PRODUCTS: TL 3000 Sirius serial numbers

ČÍSLO BULETINU / NOTICE ID: 3.S.SI.2017

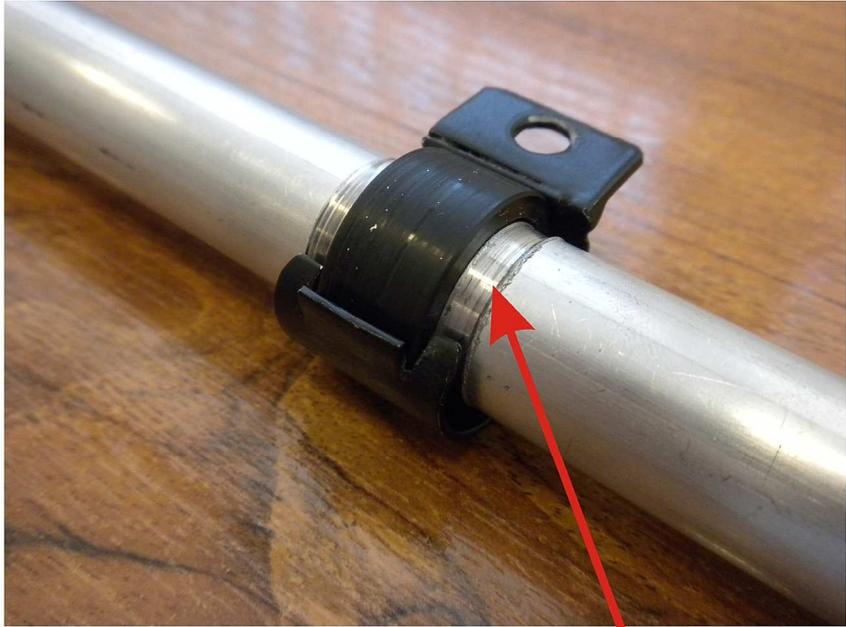
The shape of the metal that holds the sliding mount ensures the axial position of the sliding bearing that is fitted over the torque tube. Excessive bending of the two metal safeguards can lead to contact between the locking part of the metal and the rotating torque tube (especially at high speed rotation of the torque tube). This, in combination with the tube's rotation, creates a groove along the circumference of the tube that weakens its cross-section and load capacity.

<p data-bbox="316 1182 895 1223">Damage/groove in flap drive torque tube</p>

Sequence of steps	Description of Operation
	<p>- If damage to the torque tubes is found (signified by grooves in the surface of the tube) the take off is prohibited. Dismantle the flap drive torque tube along with the retaining plate and sliding guide. Contact the aircraft manufacturer immediately about your findings. Consequently, the manufacturer will replace the removed parts with newly supplied spare parts.</p> <p>- If the outer diameter of the torque tube in the support slideway is weakened to a value of 17.85 mm or smaller, it is considered that the torque tube is damaged. The torque tube should be replaced along with the complete bearing fixture.</p>
<p>6</p>	<p>Record of the completed bulletin requirements</p> <p>- Complete the record for aircraft documentation with regards to the performance bulletin. Complete the record in the following manner:</p> <p style="padding-left: 40px;">Inspected under the mandatory service bulletin 3.S.SI.2017. Inspection revealed no damage and no further action is required/revealed damage to the flap drive torque tube and parts were exchanged according to the instructions in the bulletin. The aircraft is capable of continued operation.</p> <p>Date:</p> <p>Inspection completed by: Signature</p>

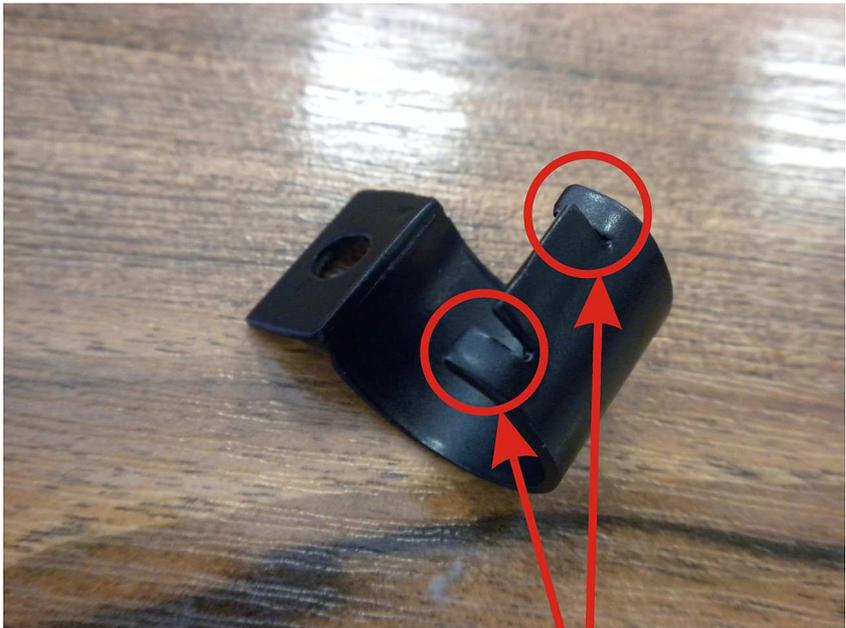
<p data-bbox="304 1935 1353 2029">The metal lugs on the support, which is used to grip the flap drive torque tube, may be excessively bent, causing operational damage to the torque tube.</p>
