**Zlin Aviation S.R.O.**

| <b>Safety Alert</b> | <b>No 09</b> | <b>20.08.2019</b> |

- **Airplanes affected:**  
All Savage Planes and models
- **Subject:**  
Visual check for possible sleeves corrosion on all stainless steel wires used for ailerons, rudder, stabilizers (\*) flaps controls (\*).  
(\*) not for Shock Cub and Shock Ultra
- **Reason:**  
A 9 years old Savage Cub with 780 flying logged hours, always hangared and operated in proximity of the sea and so in a particular corrosive environment was checked by the owner after he noted an anomalous swelling all around the sleeves area. The black heat shrinkable tube placed during the wire assembling over the sleeves, didn't allow to notice immediately the reason of the swelling so the owner decided to cut and remove the black seal, finally founding the reason of the swelling. The attached pictures show the occurred problem and how to work on it. A deep corrosion was finally reported.

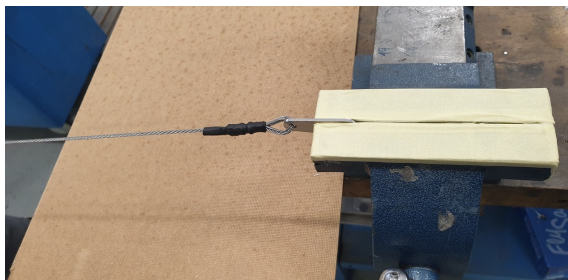
**Hold the wire**

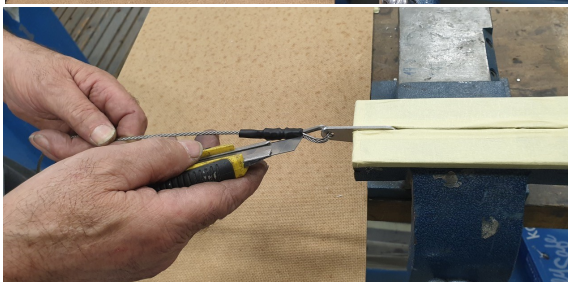
**Cut the shrinkable tube**

Remove all heat shrink tubes from sleeves so you can see the condition of the sleeves

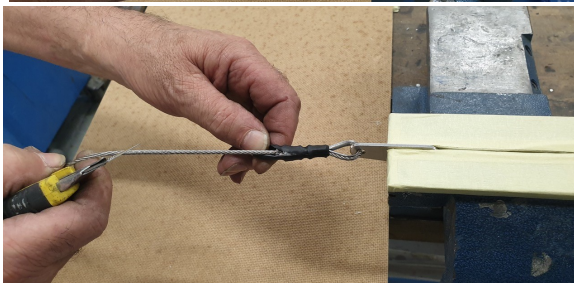
**Remove the tube**

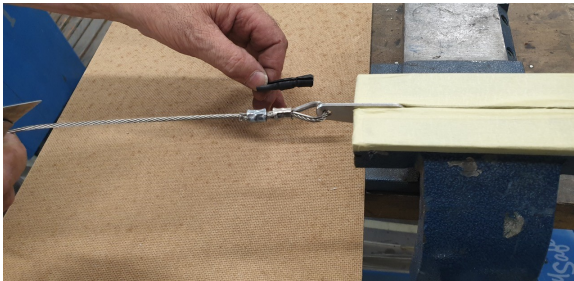
**Inspect the sleeves**

Check for any corrosion or other issues like degradation of the sleeves due to high salt concentration in the air . If you are not sure , send us some pictures for assessment

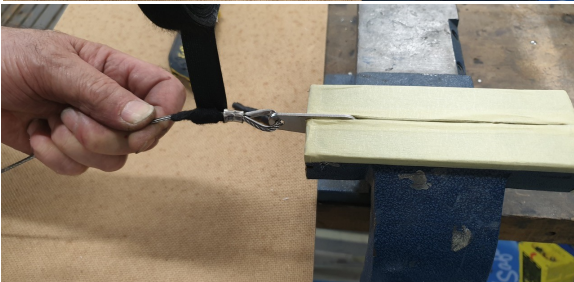
**Seal the sleeves with the Tesa tape**

If all sleeves are good with no corrosion on them or any other defects are found , you can seal the sleeves with Tesa tape used for wiring looms (or any other duck tape that suits the needs)

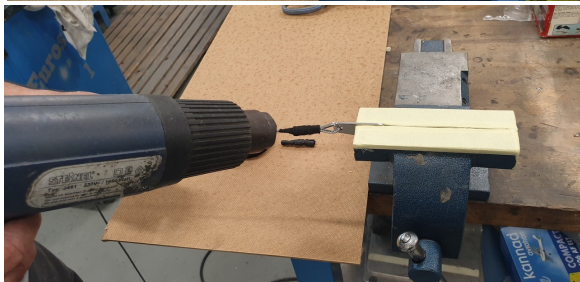
**Use small amount of heat to seal it**
