RECREATIONAL AVIATION AUSTRALIA INC

RECREATIONAL AIRCRAFT AIRWORTHINESS NOTICE

AIRWORTHINESS NOTICE IDENTIFICATION NUMBER: **AN300710-1 (Issue 2)**

INSPECTION OF WING LIFT STRUTS FOR CORROSION ON ALL THRUSTER AIRCRAFT

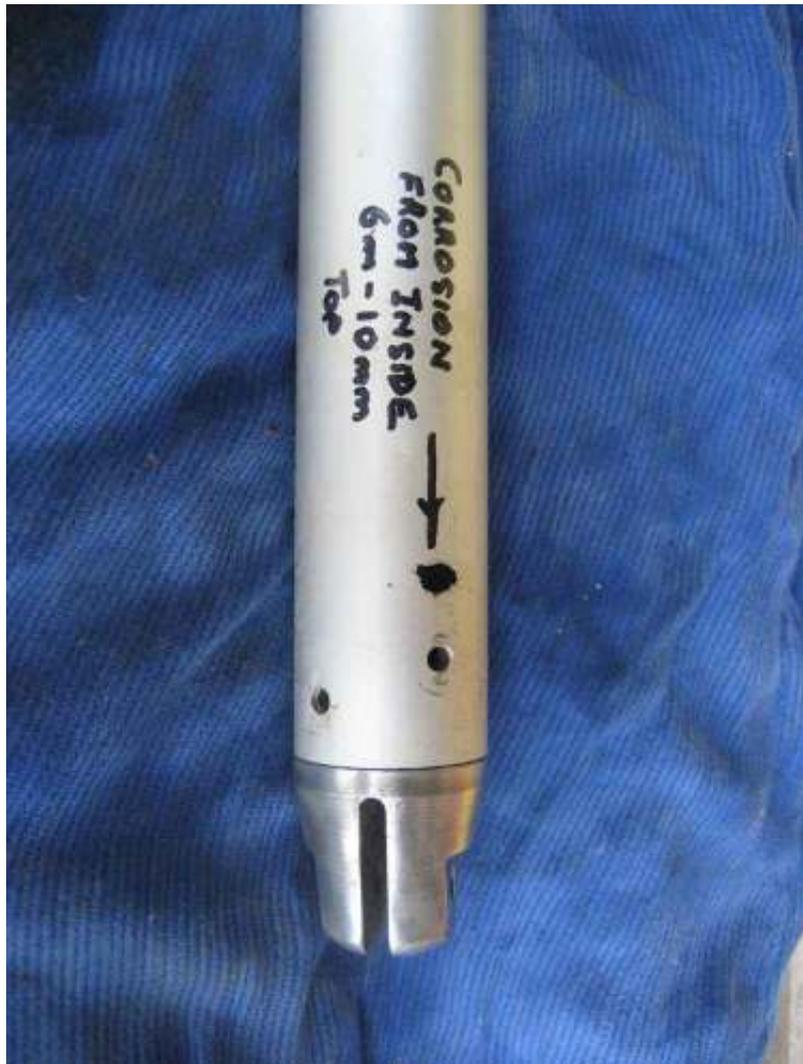
Fig 1: Corrosion from outside of the tube.

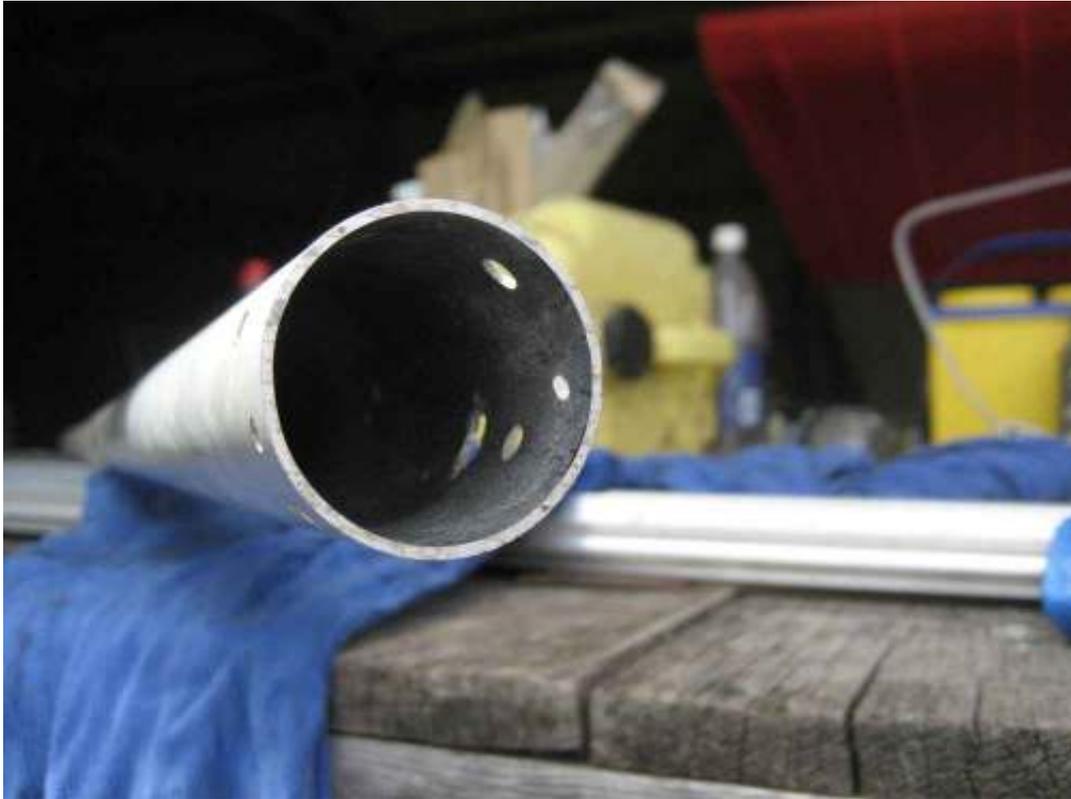
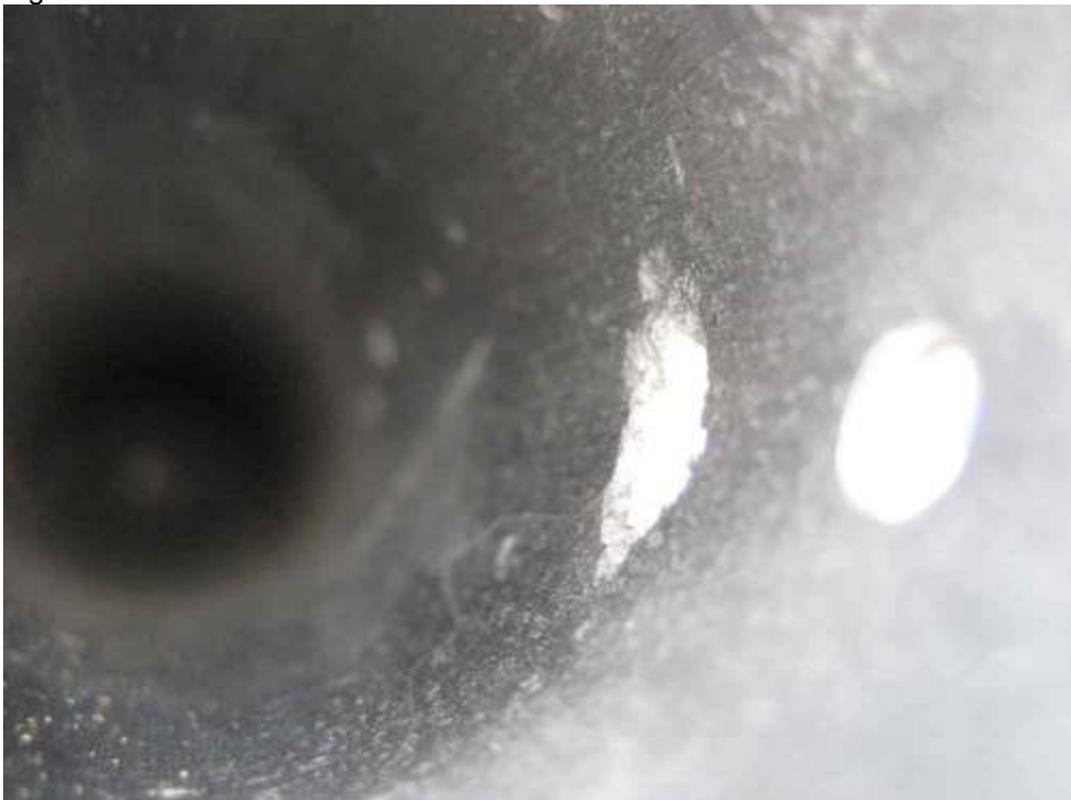
Fig 2a:

Fig 2 a and b: Internal Corrosion in strut tube.

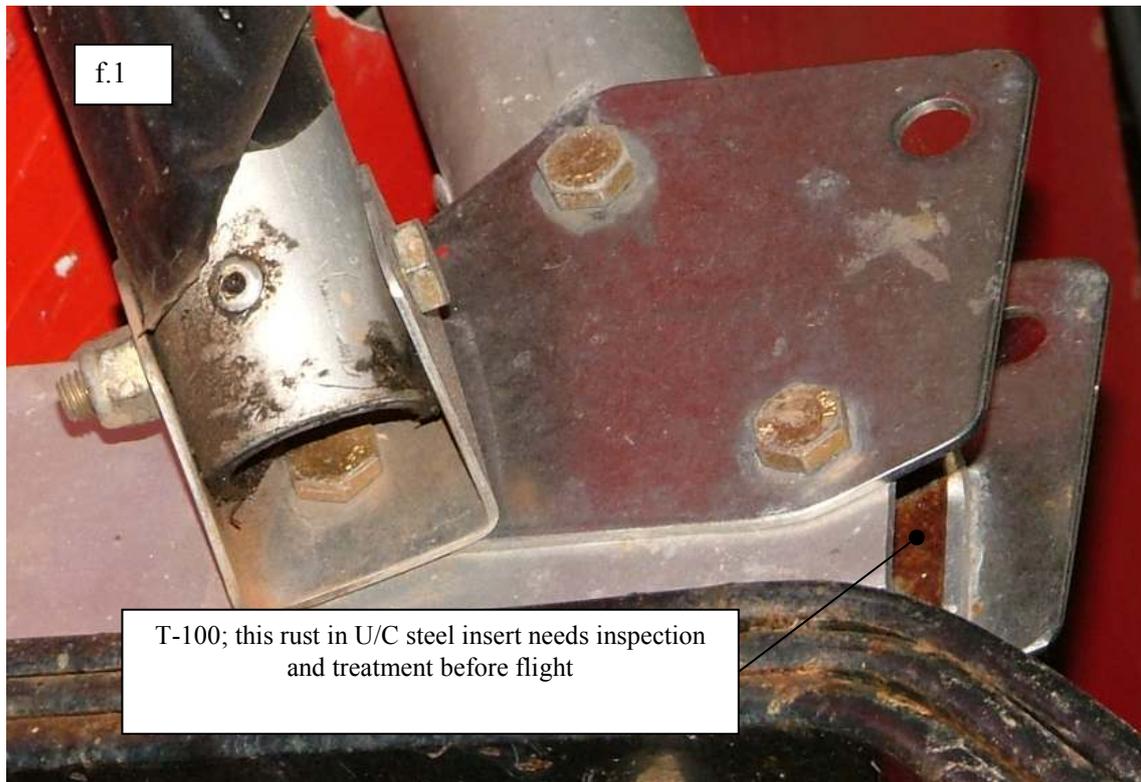
These aircraft all have a pair of thin steel plates at each end of the U/C carry-through beam, one in front and one behind, as f.1; the inner (lower) ends of the front lift struts go between these plates and a single AN-6 (two-seaters) or AN-5 bolt picks up each strut tube end and both plates.

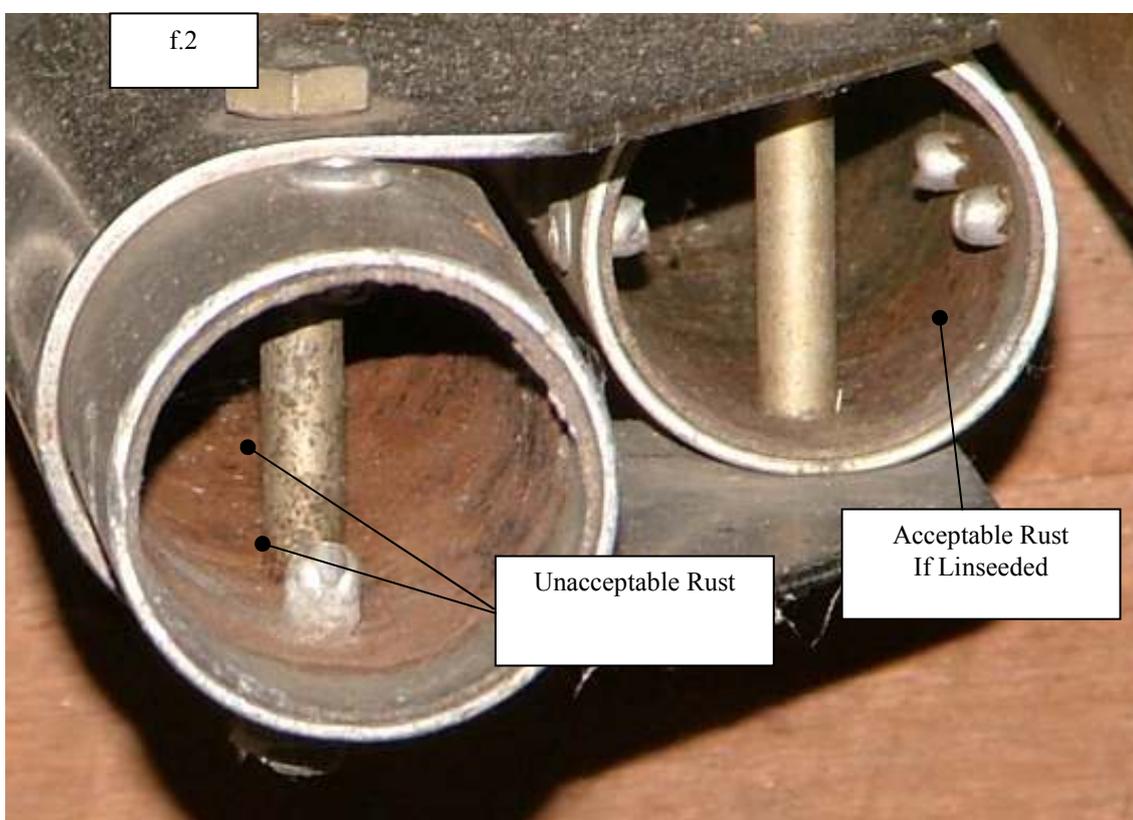
If pitting/distortion is not found, hold the root/inner end of the strut higher than the outer end and tip about a plastic cup of boiled Linseed oil into it. Roll over and slosh around a bit, then set outer end high to drain for a couple of days. Once the linseed oil film has become gummy, the strut can be refitted and used; and should be safe from internal corrosion for several years **(DO NOT NEGLECT ANNUAL INSPECTION!)**.

If the insert shows a lot of rust / any pitting, the strut will need to be completely disassembled and inspected, and the insert at least replaced. Contact TOSG for Approved replacement fittings.

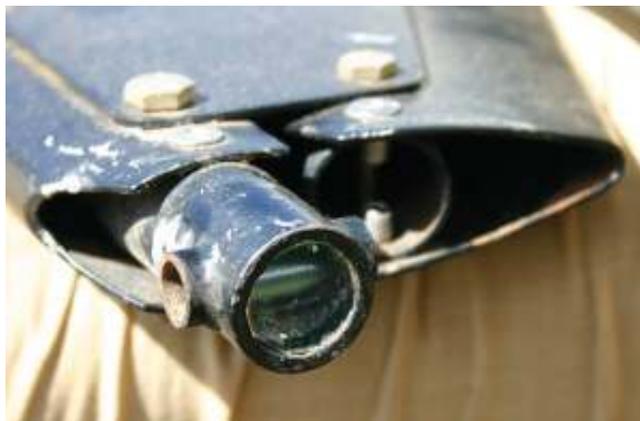
The Vision 600 has tubular steel inner strut ends, with anti-crush tubes for the through-bolts; again, an annual inspection with a dentist's mirror and torch for internal rust is warranted. If rust is found, either Vision Aircraft should have a repair scheme, or TOSG can produce one.

As the Australian Thrusters had no anti-crush tubes for the attach bolts, and many operators automatically over-tightened these bolts, a number of aircraft have had solid inserts of wood or plastic driven into the strut inner ends; these are guaranteed to cause corrosion problems, and should be immediately removed and disposed of.

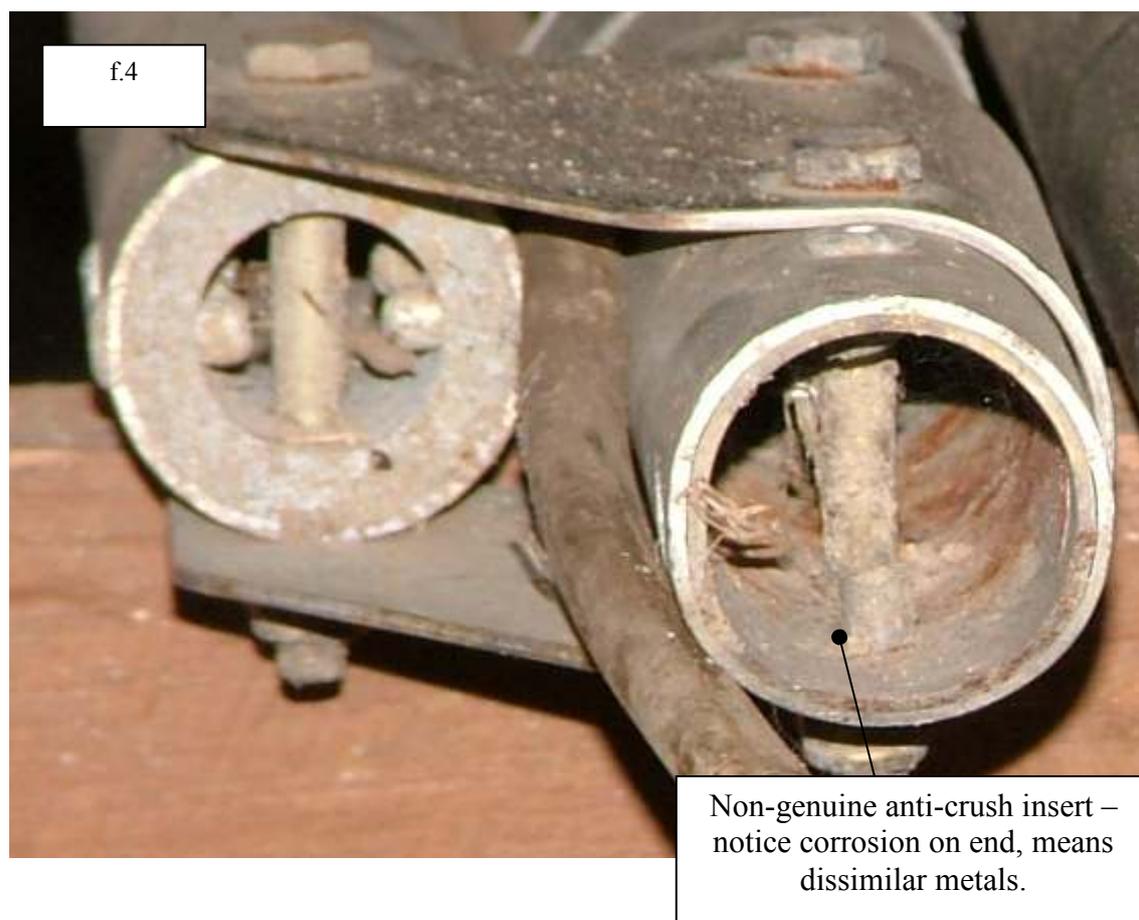
If a strut inner fitting of machined “plug” form (as per outer), or any other not described above, it is almost certainly “bogus”; contact TOSG before further flight, at the very least.

If the strut inner attach plates are not stainless steel, or the U/C carry-through beam is not aluminium (possibly with a steel insert if a two-seater), again contact TOSG. It MAY not be unsafe; or it may (if a two-seater) be an illegal modification, and should be analysed and officially blessed – or replaced – before further flight.
