RECREATIONAL AVIATION AUSTRALIA INC

RA-Aus:SB-001-07-05-2012-TL:STING

## Safety Bulletin - TL Ultralight May 2012

Effected Models: **TL 2000 Sting Carbon, TL 2000 Sting RG, TL Sting S4**

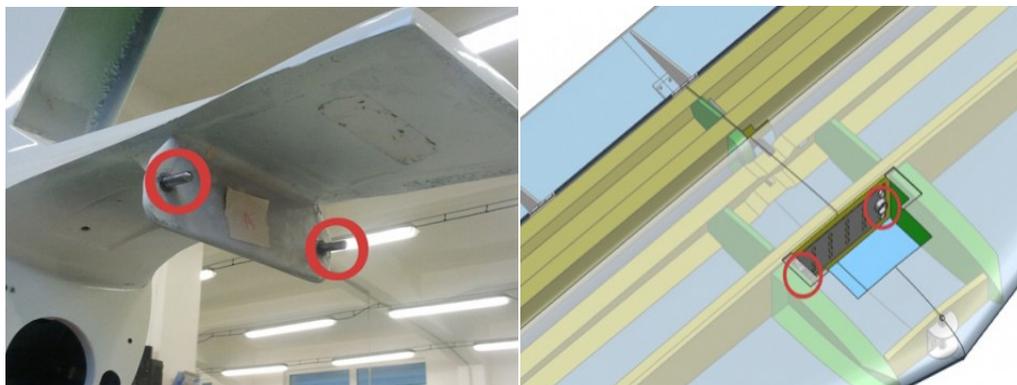
This inspection is to be performed by removing the horizontal stabiliser IAW the maintenance manual for each type of aircraft being inspected and perform a check on the mounting pins and bearings.

The locations are shown on the photographs below.

There must not be any sign of corrosion on the pins and bearings, if necessary clean them for inspection and evaluation, lubricate with grease prior to reassembly.

Aircraft of particular concern are those stored close to the ocean where they may be affected by salt spray and those aircraft which are stored and exposed to the outside weather conditions.

Aircraft that are found with any corrosion need to be photographed and reported to the RA-Aus Technical Manager and the TL Ultralight Company, for further instructions on replacement of these parts to maintain airworthiness.
