RECREATIONAL AVIATION AUSTRALIA INC

RECREATIONAL AIRCRAFT AIRWORTHINESS NOTICE

AIRWORTHINESS NOTICE IDENTIFICATION NUMBER: RA-Aus AN 200910-1 (issue 1)

COMPULSORY CHECK OF THE FUEL LINE NON RETURN VALVES IN SKYFOX AIRCRAFT

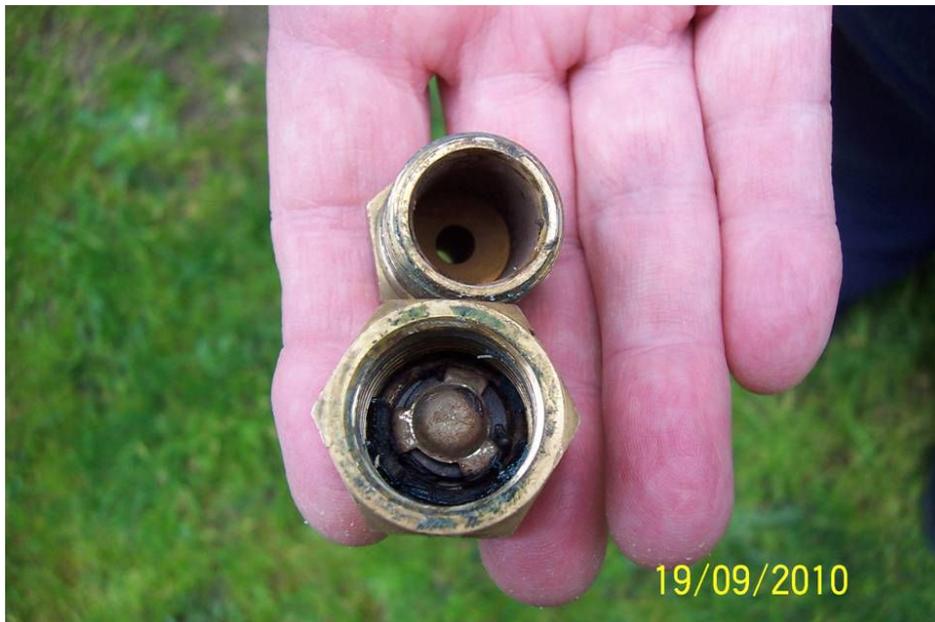
Background: An owner has reported that during routine maintenance the rubber non return valves in the aircraft fuel lines was found to be seriously degraded, see Fig 1:

Fig 1. Degraded in-line non-return valve.

Discussion: The degradation shown in Fig 1 is most likely caused by long term contact with fuel containing ethanol and/or age. Degradation of the non return valve in this system may cause fuel feed problems to the engine.

Remove the clamps and brass fitting. Using two suitable spanners open the valve casing and inspect the rubber valve mounted inside for security, damage and degradation then replace any unserviceable valves. Carefully inspect the fuel hoses for signs of ageing, hardening or softening, cracks, swelling and damage. Replace all unserviceable hoses with appropriate ethanol resistant hose.

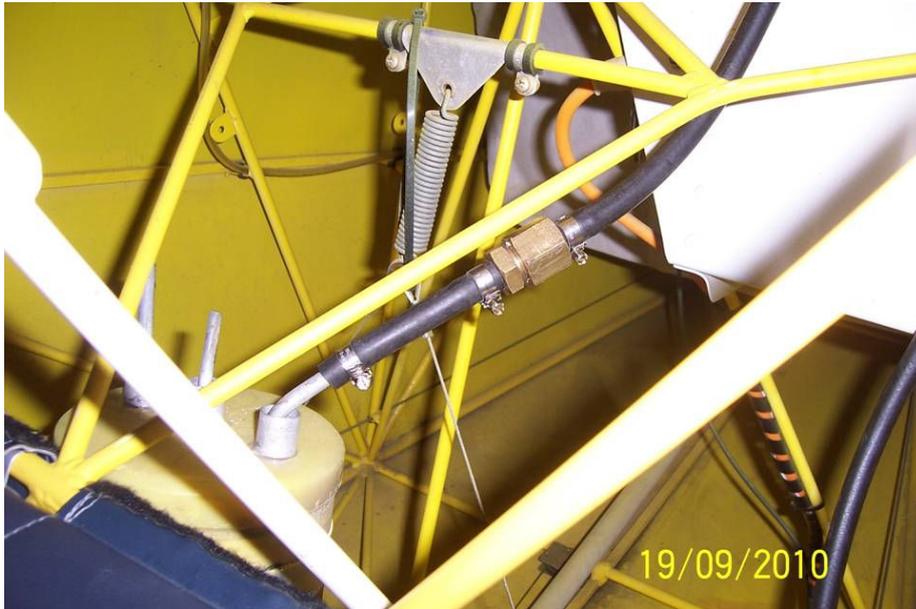
Fig 2: position of non-return valve.

BEFORE NEXT FLIGHT: Remove the brass fitting in the fuel lines which mount the non-return valve, see Fig 2 and 3.

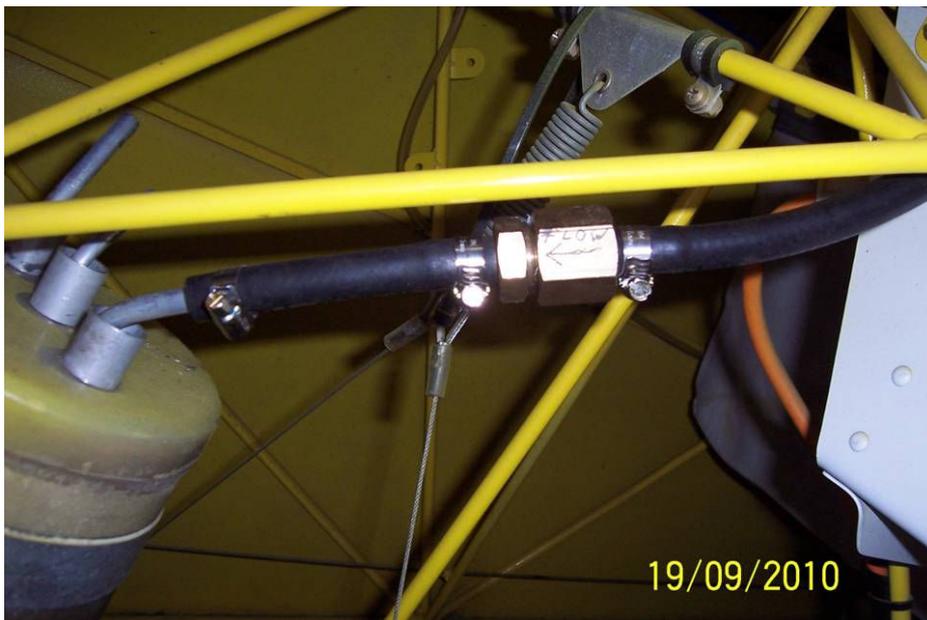
Fig 3: Close up of non-return valve.
