RECREATIONAL AVIATION AUSTRALIA INC

## RECREATIONAL AIRCRAFT AIRWORTHINESS NOTICE

AIRWORTHINESS NOTICE IDENTIFICATION NUMBER: [RA-Aus AN150911-1](#)

### VISUAL INSPECTION FOR CRACKS IN TECNAM P92 MAIN UNDERCARRIAGE SUPPORT TRUSS

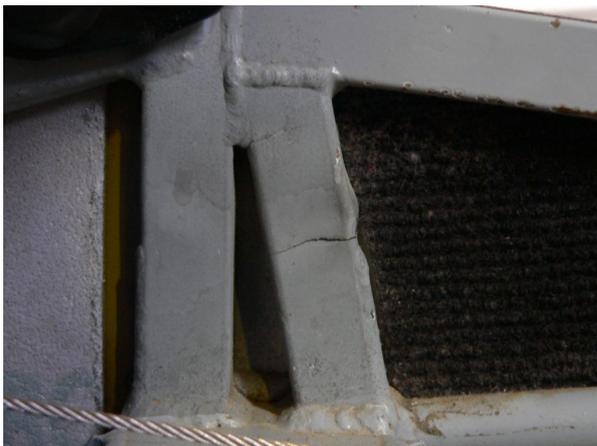
**Background:** Some owners have reported cracks in the main undercarriage support truss in Tecnam P92 aircraft operated on rough landing areas.

Cracked Support

Perform a visual inspection on the main undercarriage support truss in the cockpit area, for signs of cracking. (this is only recommended for the Tecnam P92 LSA aircraft, but is mandatory for all others). Any cracks must be repaired in accordance with Tecnam Instructions. This area is easily accessible from the cockpit, and does not require any disassembly.

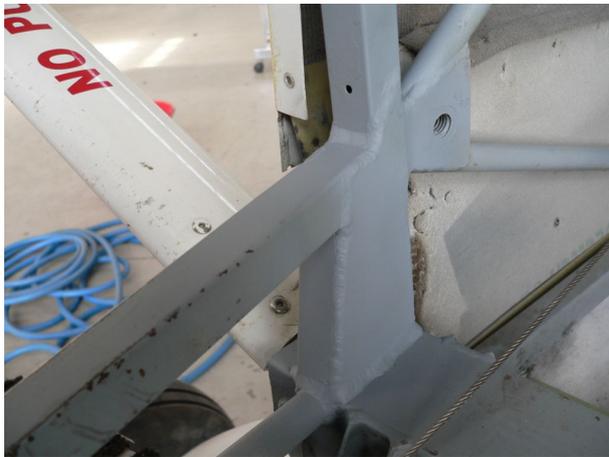
Support Repaired
