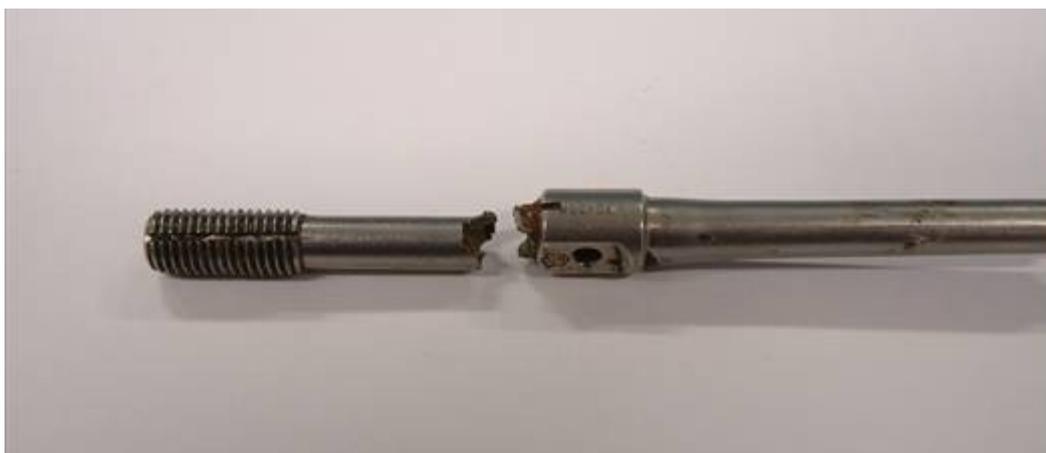
Figure 1 - Separation at threaded end of terminal

Terminal fitting separation as described in this Airworthiness Bulletin is due to chloride stress-corrosion cracking (CSCC) a form of intergranular cracking which does not provide clear visual clues to the full extent of the internal structural damage and can originate from within the terminal (See Figure 4.).

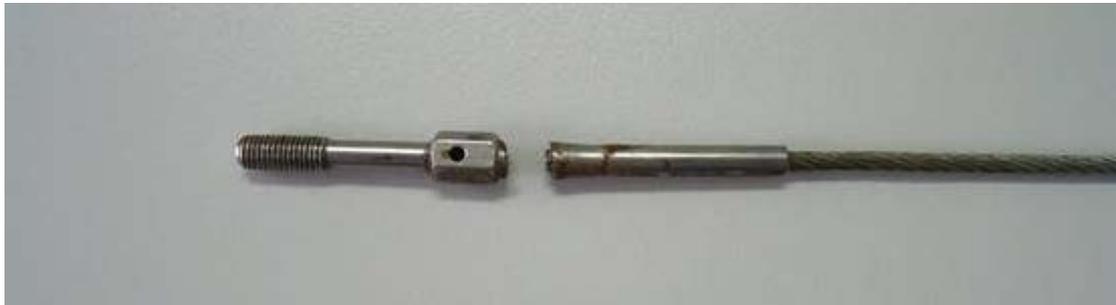
Figure 2 - Separation at swaged end of terminal

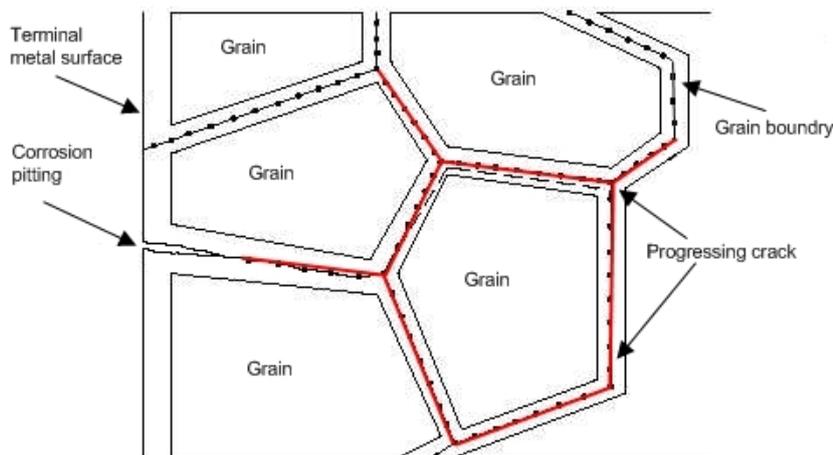
Figure 3 - Intergranular Corrosion Cracking

While the sketch above (Figure 3.) shows surface pitting as evidence of intergranular corrosion, a corroded terminal may also show small rust deposits.

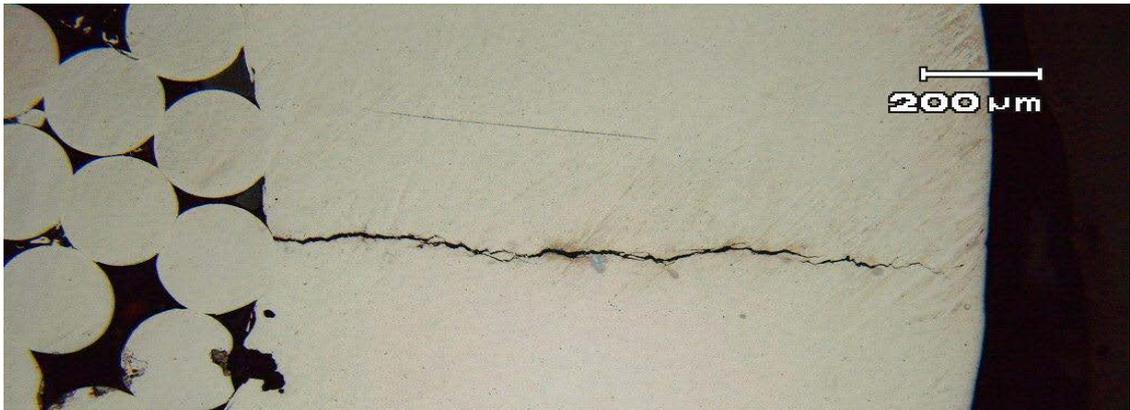
evidence of chloride stress corrosion cracking (CSCC) originating from the inside of the terminal. Since such cracking can originate from within the terminal, external surface clues such as pitting or cracking may not provide an adequate basis for determining serviceability. This introduces the possibility that a terminal may be close to failure and may even fail with little or no surface indication.

Figure 4. Internal corrosion - flight control terminal sleeve.

The crack shown in Fig. 4 originates from the cable wires (on the left of the picture) swaged in the terminal sleeve. The corrosion has not yet reached the outside surface of the terminal sleeve.

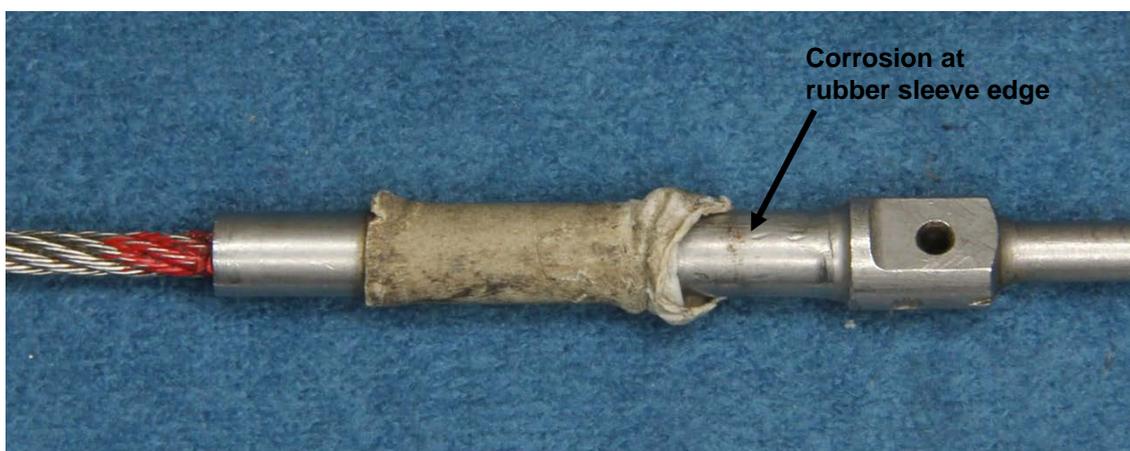
Corrosion has now been found under the rubber sleeves used for aircraft manufacturer's part number identification, as shown in Figure 5 & 6 below. During an inspection which detected corrosion on one section of a terminal, the maintainer found additional corrosion at the edge and under the rubber sleeve, when the sleeve was pulled back. Four flap control cable terminals were affected. They had been in service for approximately 13 years.

Figure 5 - Control cable terminal covered in rubber sleeve (source ATSB).

- a. Visually inspect flight control cable terminals, irrespective of the total time in service, for the presence of any rubber sleeves, tape or any other material/substance (other than lockwire) that may prevent the chromic oxide film from forming. Such material should be removed and the terminal cleaned and inspected for corrosion. Any sign of corrosion is cause for rejection.
- b. Retire all flight control cables made from stainless steel (SAE-AISI 303Se) including, but not limited to, standard flight control cable terminal part numbers AN669, MS21260 and MS20668, before reaching 15 years time since installation.
- c. Where required by aircraft maintenance documentation, flight control cables should be periodically inspected in accordance with the manufacturer's data and FAA AC 43-13-1B chapter 7, section 8, paragraph 7.149d.

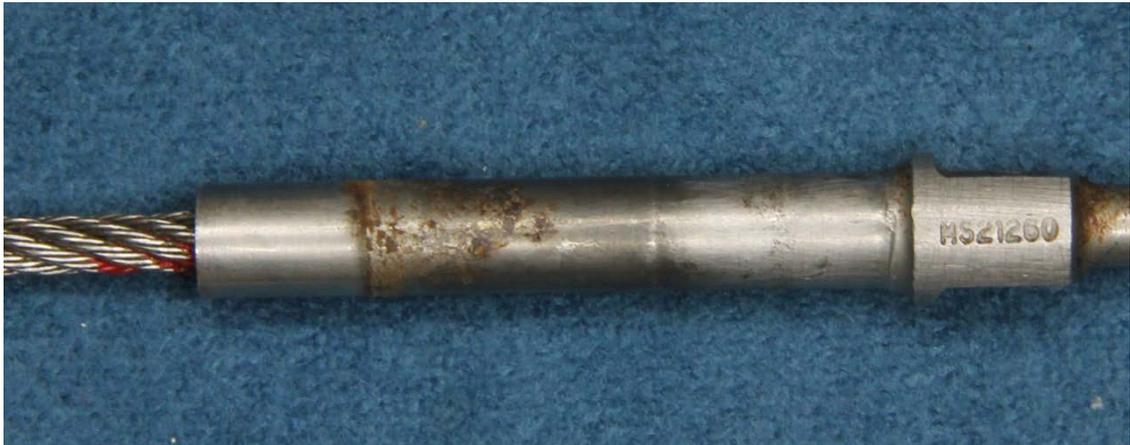
Figure 6 - Control cable terminal shown in figure 5, with rubber sleeve removed (source ATSB).

Stainless steel's resistance to corrosion is primarily attributed to the existence of a thin chromic oxide film which develops in the presence of oxygen in the atmosphere. Stainless steel must be in continual contact with oxygen in order to develop and maintain the integrity of the film. A breakdown in an area of the oxide film due to lack of oxygen can allow localised corrosion cells to form. The presence of the rubber sleeves over the terminals prevented the chromic oxide film to form, allowing corrosion to develop.
