AIRWORTHINESS BULLETIN

Aircraft Lead Acid Main Battery Failures

AWB 24-008 **Issue :** 1
Date : 16 September 2013

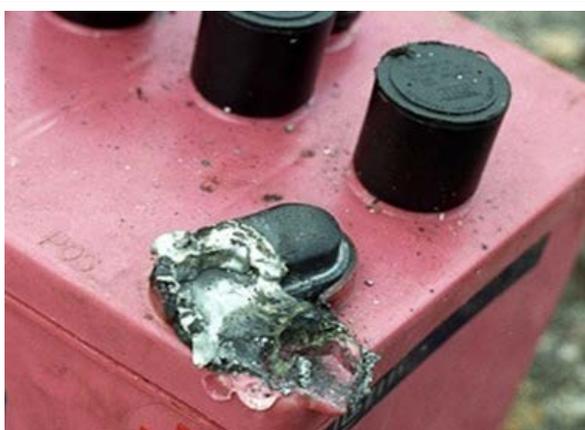
Figure 1

Battery terminal separation failures (pictured) are typically caused by excessive heat resulting from high current draw during engine starter motor cranking the engine and high resistance between the battery terminal post and the aircraft main system supply terminal.

High battery terminal resistance can be caused by inadequately torqued battery terminal attaching hardware, or tight terminal connections but having a layer of corrosion build-up between the contact faces of the battery terminal and the aircraft main system supply

1. Remove the battery from the aircraft for servicing (usually about every twelve months) and check that the aircraft battery compartment is serviceable, secure and clean, has adequate anti-corrosive coatings and that the drain and vent tubes are secure, clear and correctly oriented.
2. Any time the battery is removed, consider rinsing the empty battery compartment (and lid) with a water and baking soda solution to neutralise any acid and to check battery compartment drain function.
3. Check that the battery structural tie-down arrangement is serviceable.
4. Inspect the battery case for deterioration, cell caps for function and cells for charge state. If the battery terminals are damaged, loose or deformed, the battery should not be installed.

5. Before installing any battery, ensure the battery is the correct model for the application, including battery terminal polarity and aircraft wiring system polarity and orientation in relation to the battery container.
6. Ensure that the battery terminals and the aircraft cable terminals are clean and free from corrosion, oxidation, chafing and contamination and take care to observe correct terminal attaching hardware sequence, using the OEM hardware supplied with the battery.
7. Ensure the battery terminal wing nuts are adequately tightened, that the battery is properly secured and the battery container cover is correctly installed.

CAUTION. Do not over tighten the terminal wing nut. Over tightening may result in deformation of the terminal post material which will eventually result in the terminal post becoming loose in service.

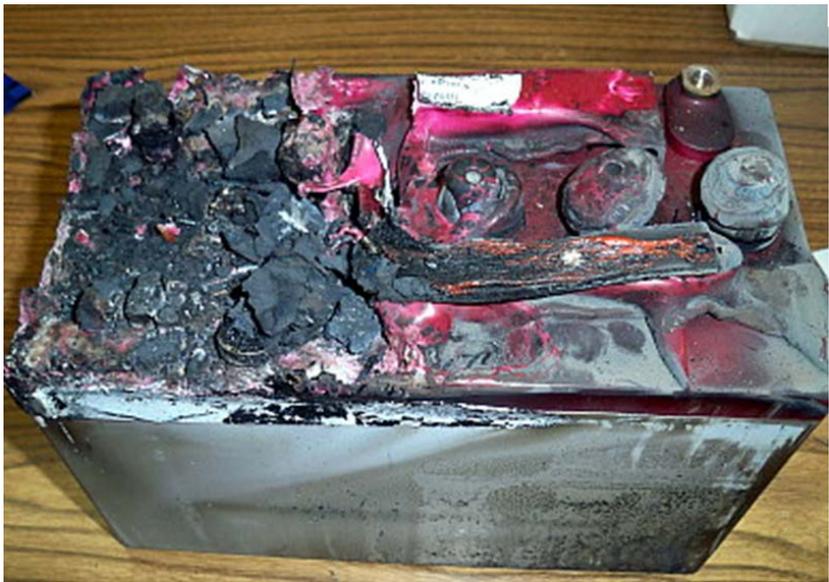
Figure 2

During a period of high current draw, typically during extended engine starting attempts on the ground, explosive mixtures of hydrogen gas accumulate in the aircraft battery compartment. Should a battery terminal overheat to the point of melting, the spark generated as it separates from the battery can ignite the hydrogen and oxygen gas mixture given off by the discharging battery and has resulted in an explosion and fire on more than once occasion. (See Figure 2).

Because the typical simple small aircraft battery compartment venting system works best during flight, explosive and noxious mixtures of hydrogen gas can accumulate in the battery box during both starting and charging on the ground, when there is insufficient air circulation in the aircraft battery compartment. For this and many other reasons, battery manufacturers generally advise against "jump" starting an aircraft using an alternate external battery power source when the installed aircraft battery has been depleted. Such action also allows the aircraft alternator to immediately deliver a high charge rate to the depleted battery, which will occur even at idle RPM on the ground following a "jump" start and can damage the battery.

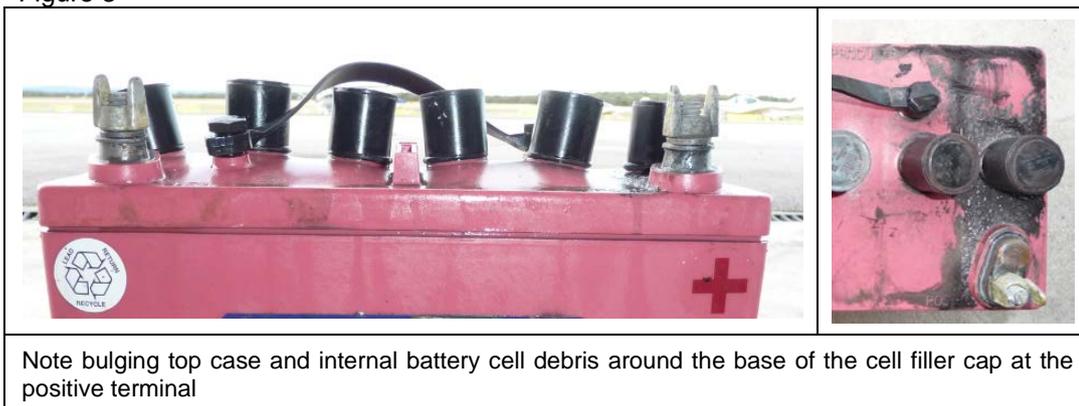
Figure 3

Some batteries have failed with sections of the top part of the case bulging upward, due to a combination of overheating, low electrolyte levels, internal failure and pressure build-up inside the battery case, due to the rubber tip seal in the cell cap failing to re-open. (See Figure 3). Aircraft battery cell caps allow the individual cells to vent gasses and also have some form of “non-spill” arrangement inside the cap to prevent electrolyte leakage from the cell during turbulence and unusual manoeuvres. A popular version of non-spill cap uses an inverted hollow “U” shaped lead weight which pulls a rubber tip into the vent hole and seals the cell when the battery is in unbalanced flight. (See Figure 4).
