RECREATIONAL AVIATION AUSTRALIA INC.

## RECREATIONAL AIRCRAFT AIRWORTHINESS NOTICE

### AIRWORTHINESS NOTICE IDENTIFICATION NUMBER: 12082014

#### **FLYING CONTROL SYSTEM – SWAGED CABLE INSPECTION. ADVISORY INSPECTION.**

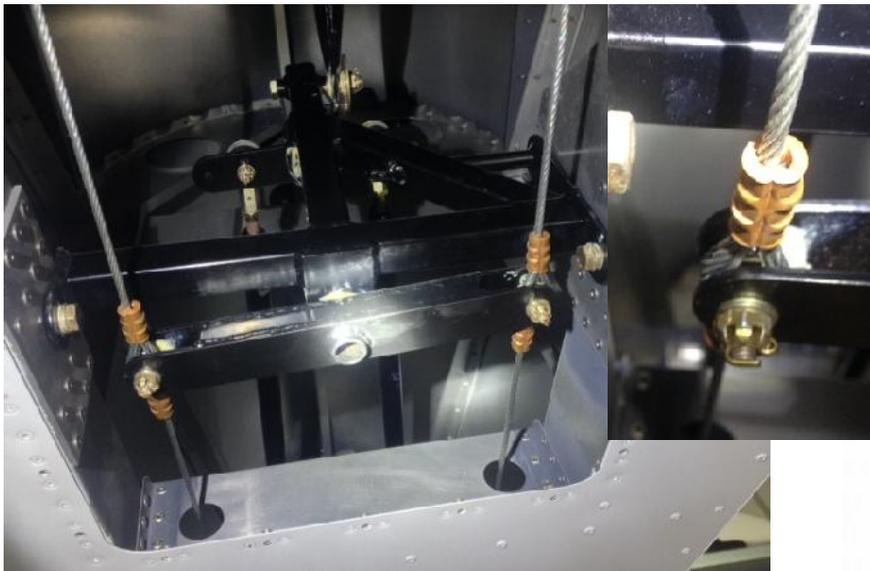
A recently received incident report has identified an area of concern relating to the integrity of primary flight controls swaged cable on a Sonex Waix. This was identified during an aircraft condition report (ACR). As a result Recreational Aviation Australia Inc. has created this airworthiness notice.

1 As can be seen in the above picture the control cable has been swaged but the cable isn't protruding from the end of the swage. The black and white diagram clearly illustrates how the cable should be presented. These cables were supplied from an aircraft manufacturer with a kit. They have since replaced the cables with serviceable units.

2 On completion of the inspection if any issues are identified, a Recreational Aviation Australia incident report is to be completed and sent to the Technical Manager. On completion of the inspection, if nil defects are evident, a statement to that effect is to be recorded in the aircraft airframe log book citing 12082014.

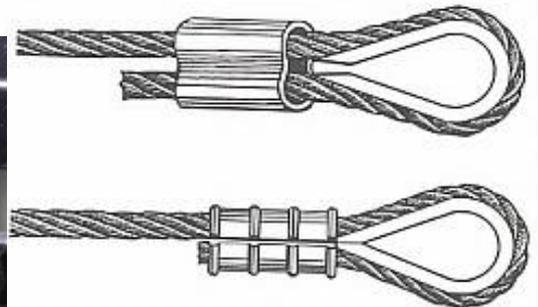
Typical thimble-eye splice.

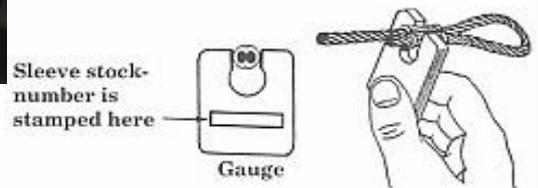
Typical terminal gauge.
