ZÁVAZNÝ SERVISNÍ BULETIN / MANDATORY SERVICE BULLETIN

TÝKÁ SE / CLARIFICATIONS: Damage to the flap drive torque tube in the fuselage.

OVLIVNĚNÉ VÝROBKY / AFFECTED PRODUCTS: TL 3000 Sirius serial numbers

ČÍSLO BULETINU / NOTICE ID: 3.S.SI.2017

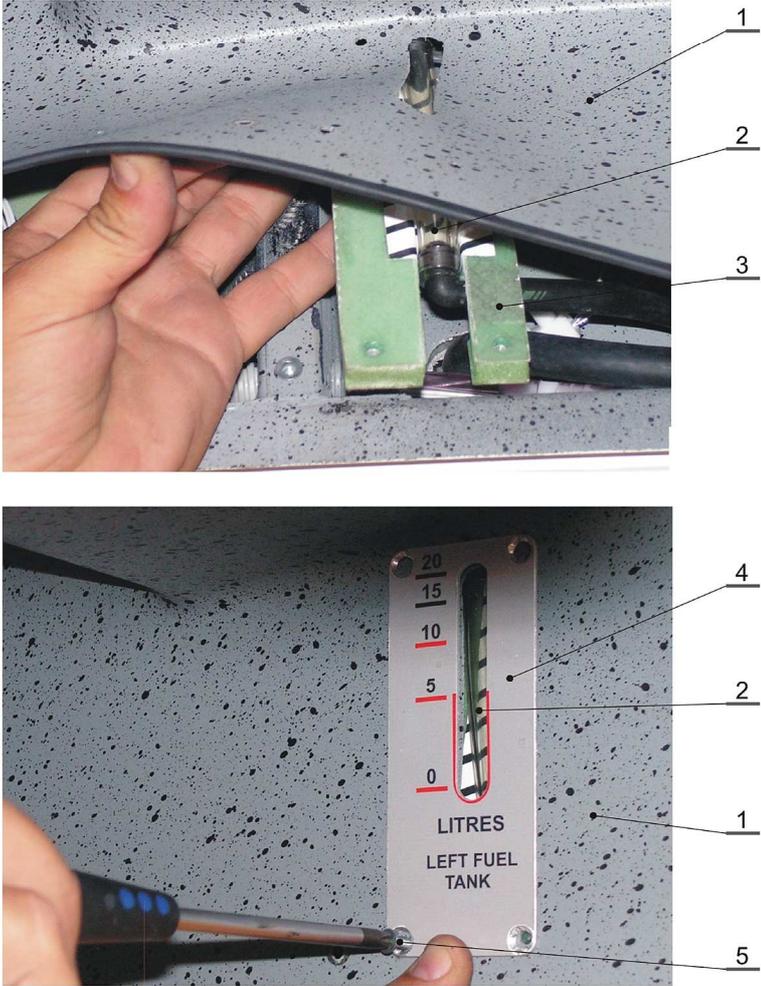
<p data-bbox="379 1709 932 1888"> 1 ... Composite ceiling panel 2 ... Transparent fuel gauge cylinder 3 ... Internal part of the fuel gauge 4 ... Outer metal part of the fuel gauge 5 ... M4x12 screw </p> </div>

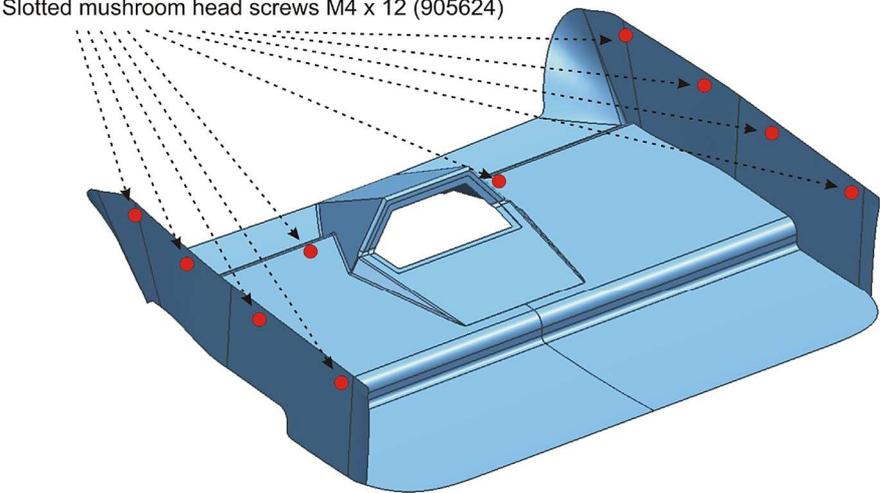
Sequence of steps	Description of Operation
<p style="font-size: 2em; font-weight: bold;">4</p>	<p style="font-weight: bold;">Dismantling the composite ceiling panel</p> <p>- Remove the composite ceiling panel. The panel is attached to the aircraft with M4x12 bolts and Velcro strips.</p> <div style="text-align: center;"> <p>Slotted mushroom head screws M4 x 12 (905624)</p>

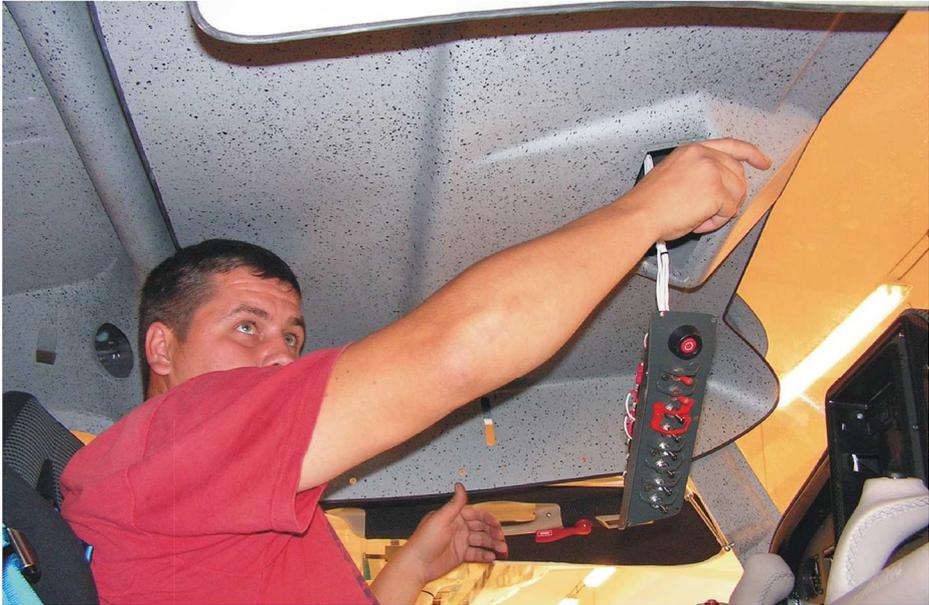
</div> <p>- After removal of the ceiling panel, the flap drive torque tube is open for inspection</p>

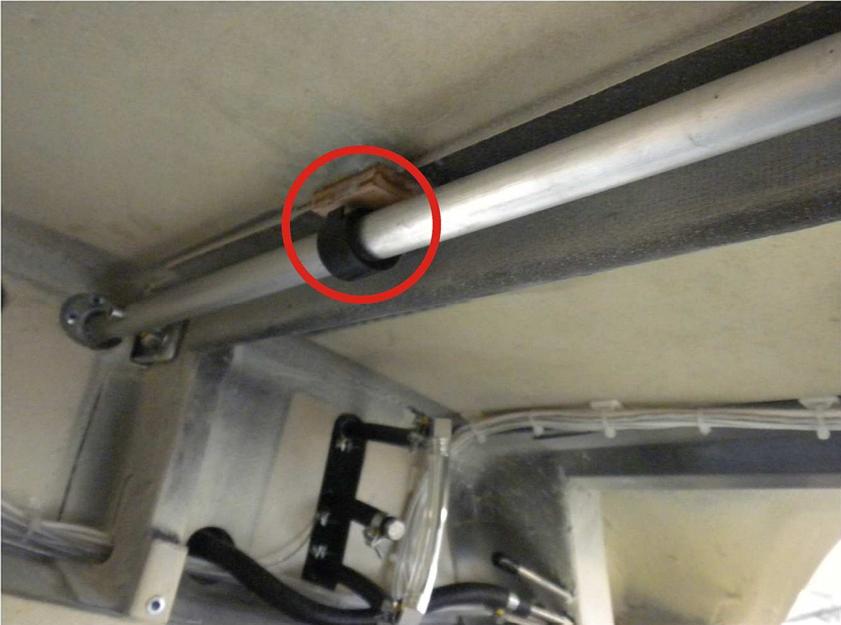
Sequence of steps	Description of Operation
<p style="font-size: 2em; font-weight: bold;">5</p>	<p style="font-weight: bold;">Inspection of the torque tube</p> <p>- Inspect the flap drive torque tube for the presence of damage at the location of the fixed plastic support (1 or 2 depending on the aircraft type).</p> <div style="display: flex; justify-content: space-around; margin-top: 20px;"> <div style="text-align: center;"> <p>variant A</p> <p>2 supports at either side of the tube.</p>

<p data-bbox="316 1182 895 1223">Damage/groove in flap drive torque tube</p>

<p data-bbox="304 1935 1353 2029">The metal lugs on the support, which is used to grip the flap drive torque tube, may be excessively bent, causing operational damage to the torque tube.</p>

Sequence of steps	Description of Operation
	<p>- If damage to the torque tubes is found (signified by grooves in the surface of the tube) the take off is prohibited. Dismantle the flap drive torque tube along with the retaining plate and sliding guide. Contact the aircraft manufacturer immediately about your findings. Consequently, the manufacturer will replace the removed parts with newly supplied spare parts.</p> <p>- If the outer diameter of the torque tube in the support slideway is weakened to a value of 17.85 mm or smaller, it is considered that the torque tube is damaged. The torque tube should be replaced along with the complete bearing fixture.</p>
<p>6</p>	<p>Record of the completed bulletin requirements</p> <p>- Complete the record for aircraft documentation with regards to the performance bulletin. Complete the record in the following manner:</p> <p style="padding-left: 40px;">Inspected under the mandatory service bulletin 3.S.SI.2017. Inspection revealed no damage and no further action is required/revealed damage to the flap drive torque tube and parts were exchanged according to the instructions in the bulletin. The aircraft is capable of continued operation.</p> <p>Date:</p> <p>Inspection completed by: Signature</p>
