ADVISORY NOTICE

REFERENCE NUMBER	ADN/Bushcat/1
TITLE	Skyreach Bushcat Seat Belt Harness Inspection
APPLICABILITY	All RAAus registered Skyreach Bushcat aircraft
ACTION	Recommended inspection of all seat belt harnesses. Inspect for deterioration due to mechanical wear, UV exposure, or chemical damage. Fraying is easy to identify however other types can be more difficult to spot. Pay particular attention to attachments and sewn joins for evidence of deterioration. If deterioration is found, RAAus recommends the aircraft is not flown until a replacement has been supplied from the manufacturer.
COMPLIANCE	RECOMMENDED BEFORE FURTHER FLIGHT
REPORTING REQUIREMENTS	On completion of inspection, if any defects are identified, a Recreational Aviation Australia Occurrence report is to be completed through the website oms.raa.asn.au . On completion of the works, a statement is to be recorded in the aircraft maintenance log book citing ADN/ Bushcat/1

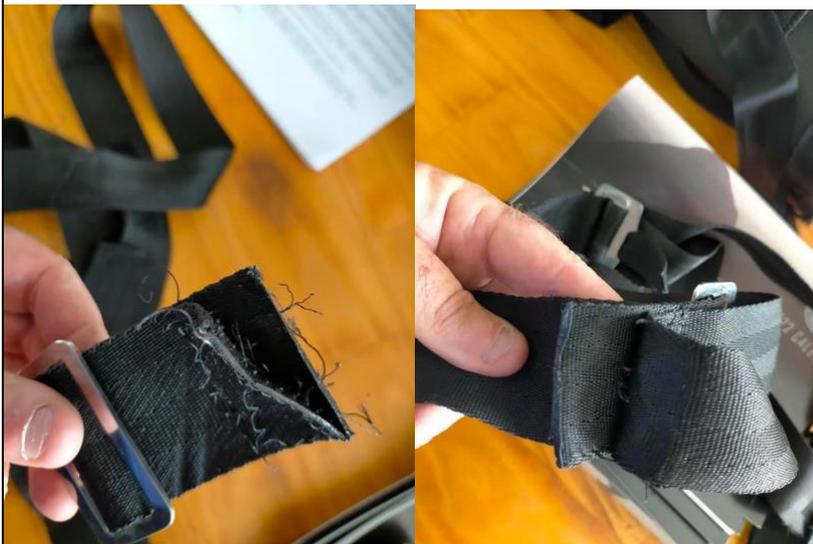
Failed left hand shoulder strap

Same location on right hand shoulder strap

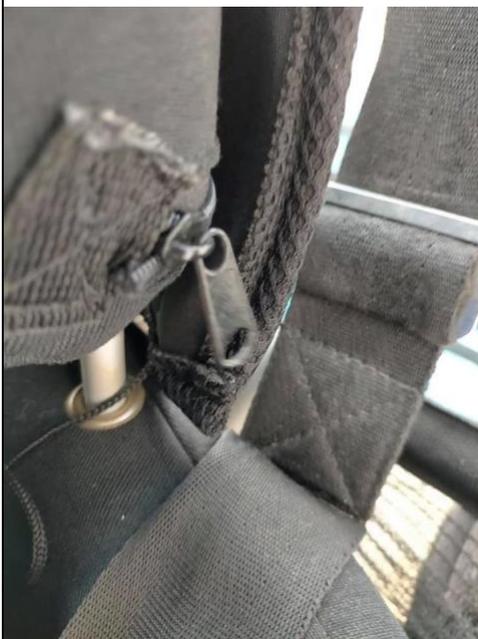
BACKGROUND	<p>Report received through the RAAus Occurrence Management system:</p> <p>Whilst the PIC was securing the seat belt harness by tightening the left hand shoulder strap, they heard a tearing sound and the shoulder harness extended. Further tightening of the harness resulted in the entire harness coming adrift from the aircraft.</p> <p>Upon inspection, the sewn portions of the harness behind the top of the seat backrest had come loose causing the individual pieces of the harness to separate. Further investigation of other harness pieces revealed the same fault. See images below.</p> <p>Contact Global Aviation Products for further information. See gap.aero</p>

Location of initial failure
